Lower Cape Fear Water & Sewer Authority Kings Bluff Regional Raw Water Supply Facilities FY 2023-2024 Annual Inspection Report

**LOWER CAPE FEAR WATER AND SEWER AUTHORITY
KINGS BLUFF REGIONAL RAW WATER SUPPLY SYSTEM
ANNUAL INSPECTION REPORT
TABLE OF CONTENTS**

Lower Cape Fear Water & Sewer Authority Bladen Bluffs Regional Surface Water Treatment Facilities

FY 2023-2024 Annual Inspection Report

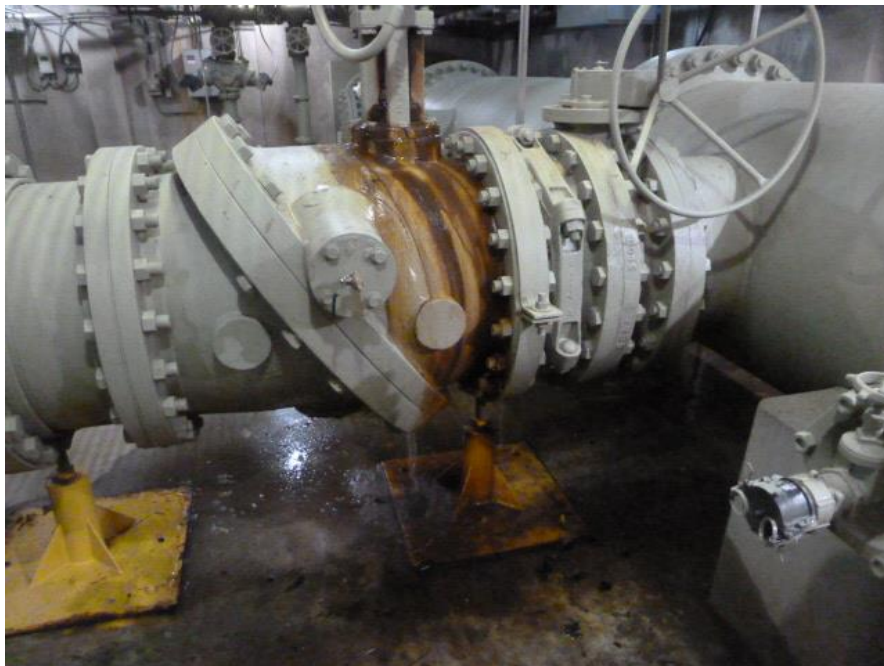
During this year's inspection, the 1,600 HP vertical turbine pumps (installed as part of the 2009 expansion/upgrade of the Kings Bluff facility) were inspected and found to be in excellent condition and meeting the needs of the Authority's customers (See *Appendix F -Photograph A*). Staff indicated that the scheduled service of Pump 5 was completed this year. During this visit, it was noted that the check valve on pump 1 was leaking significantly. Staff indicated that Underwood was in the process of rebuilding the check valve removed from 5 (noted above) for installation at pump 1 (See *Appendix F - Photographs B*).

Photograph B – Check Valve on Pump #1 Leaking

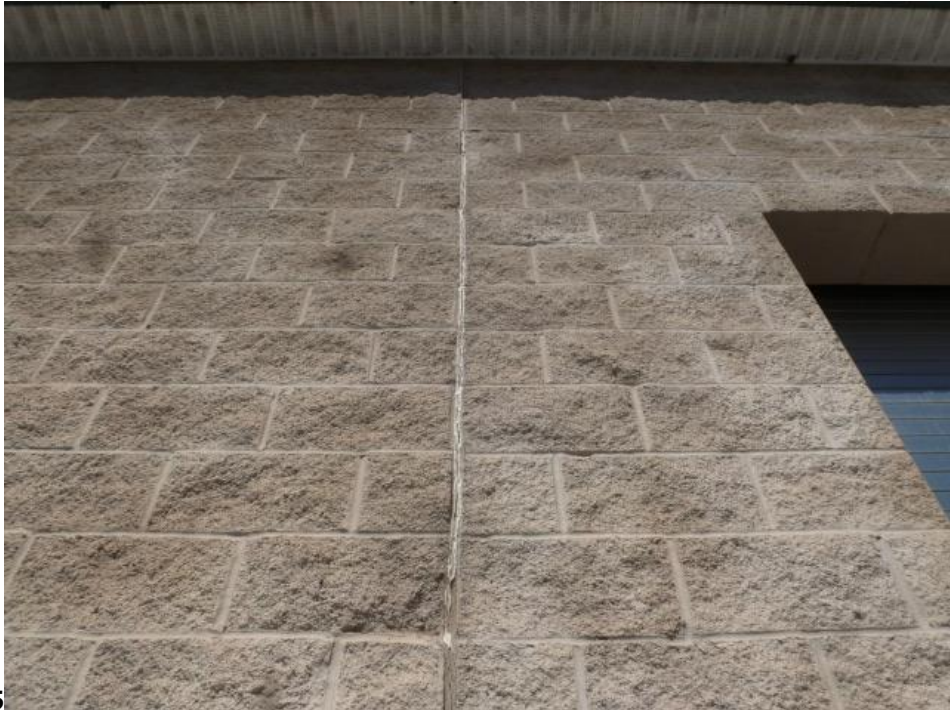
The 1,600 HP pumps are controlled by a separate electrical control room housing variable frequency drives and motor starters. During the 2016 inspection, it appeared that the masonry wall to wall joints located inside the new pump station electrical building had shifted producing cracked paint at the intersection of the walls. The most noticeable crack is located on the masonry wall joint located west of the western most roll up door. Since the 2016 inspection, Engineer reviewed the joints and found that the issue was not structurally detrimental; however, it was recommended that staff should continue to monitor the issue. During this inspection, visual observation indicated that the size of the separation did not appear to have increased (See *Appendix F - Photographs C*). It is recommended that the wall separation continue to be monitored.

Photograph C – Existing Crack in Electrical Building Wall

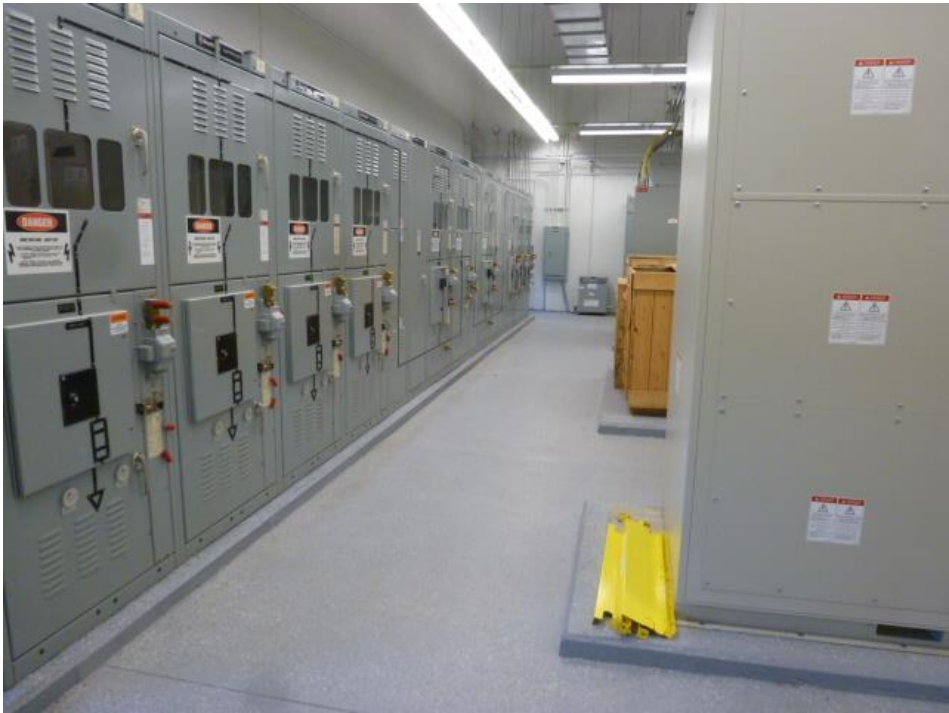
During a previous review, it was noted many items were being stored inside the electrical room creating a potential fire hazard and impeding access to exit doors. It was therefore recommended the room be cleared of excessive storage and those items that remain be moved so as to not obstruct exit from the building Staff has minimized the storage and obstruction as of this review (See *Appendix F - Photographs D*).

Photograph D –Electrical Room

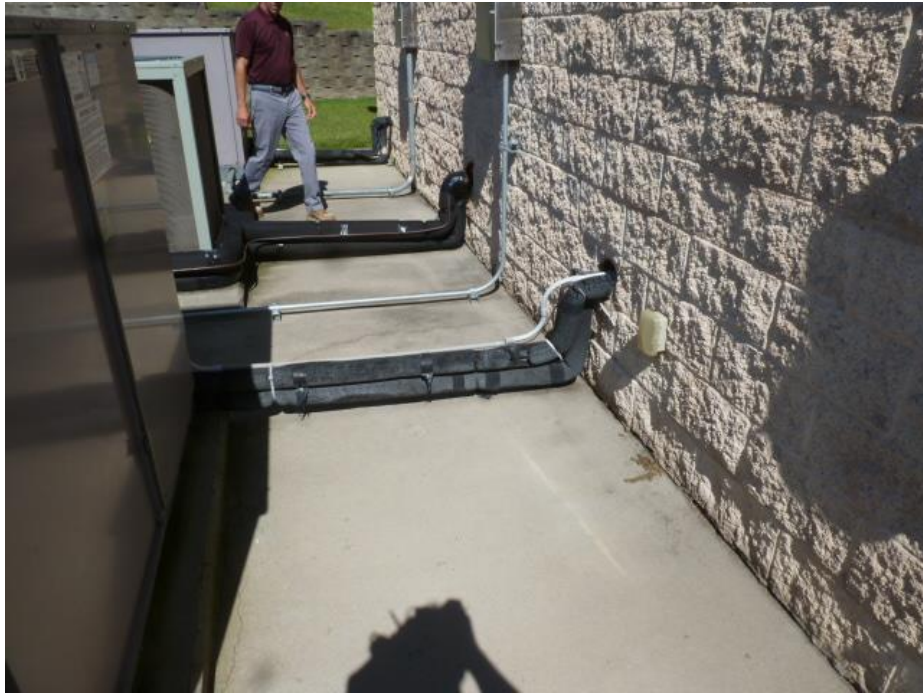
Adjacent to the new electrical control room is an HVAC room housing the HVAC equipment (See *Appendix F - Photographs E*). As noted during the last inspection, a new HVAC unit had been installed outside with an associated air handler inside. It was recommended then that the HVAC openings which allow duct work to pass between the HVAC room to the electrical room be sealed to prevent short circuiting of the unit and the unnecessary cooling of the HVAC room. As of this inspection, opening is still present, however staff indicated it was soon to be addressed (See *Appendix F - Photographs F*). All exterior HVAC units were reviewed and were clear of any debris blocking the radiator coils. It was however noted that HVAC piping insulation outside had failed in a few areas and thus it is recommended it be addressed (See *Appendix F - Photographs G*).

Photograph G – Failing HVAC Coolant Insulation

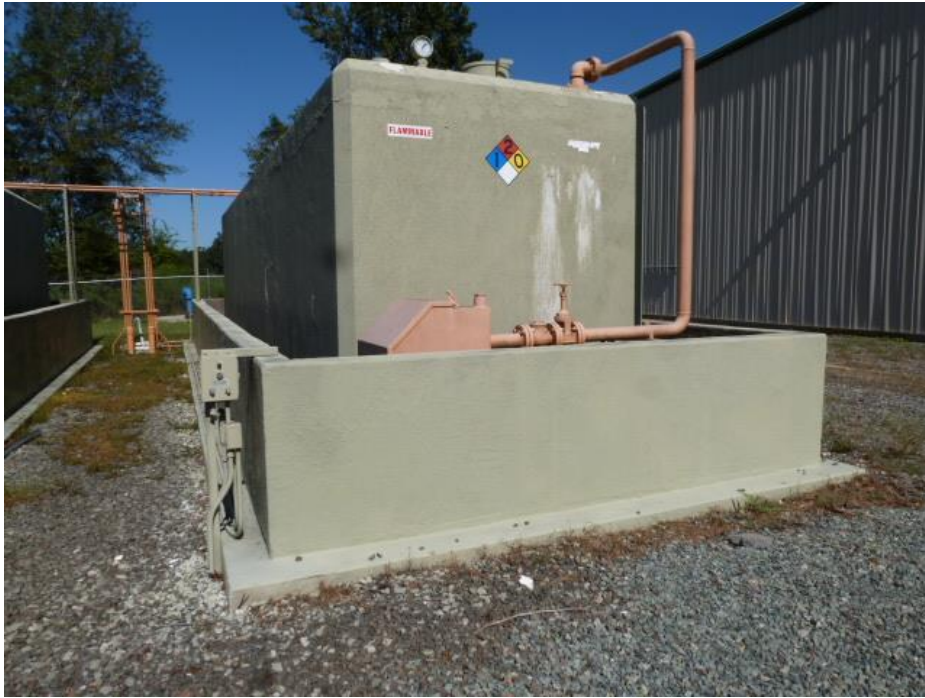
Photograph I – Diesel Storage Tank Efflorescence

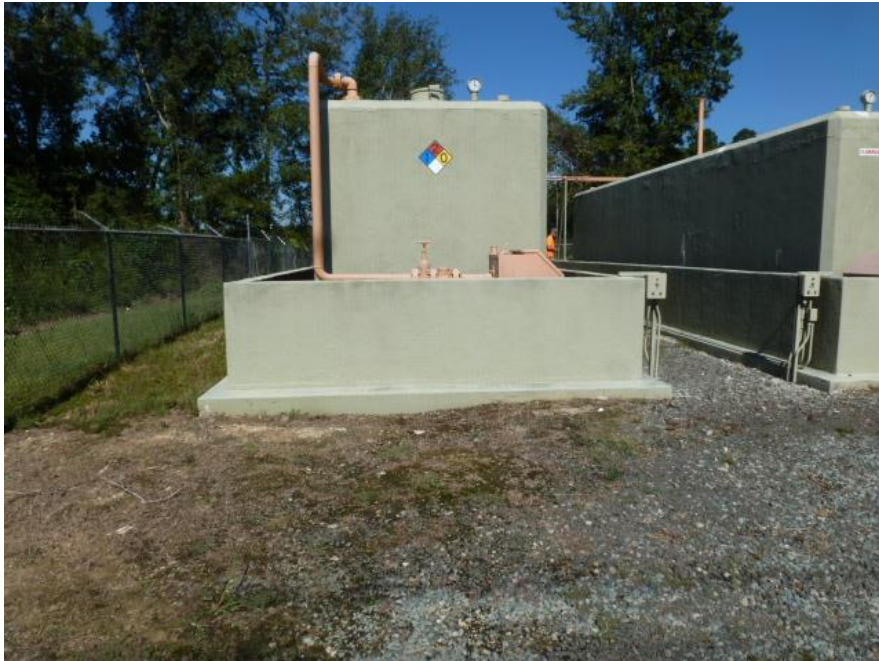
The two 3.0 Mega Watt standby generators are supplied fuel by (2) 12,000-gallon concrete fuel tanks, which are located adjacent to the generator building. The tanks were installed with a 110% secondary containment wall to capture overflow, ruptures, or spills of diesel fuel. The external fuel tanks were inspected and found to be in acceptable condition. Rainwater collects in the containment area and is drained by LCFWSA operator after each significant rain event. On both tanks, during past inspections, significant efflorescence was noted. Tanks were coated again last year; however, during this year's inspection one tank was again exhibiting efflorescence (See *Appendix F - Photograph I*). The diesel storage tank 1 leak detection test button was found to be failed and needs to be addressed (*Appendix F - Photographs J*).

Photograph J – Diesel Tank with Failed Leak Sensor Panel

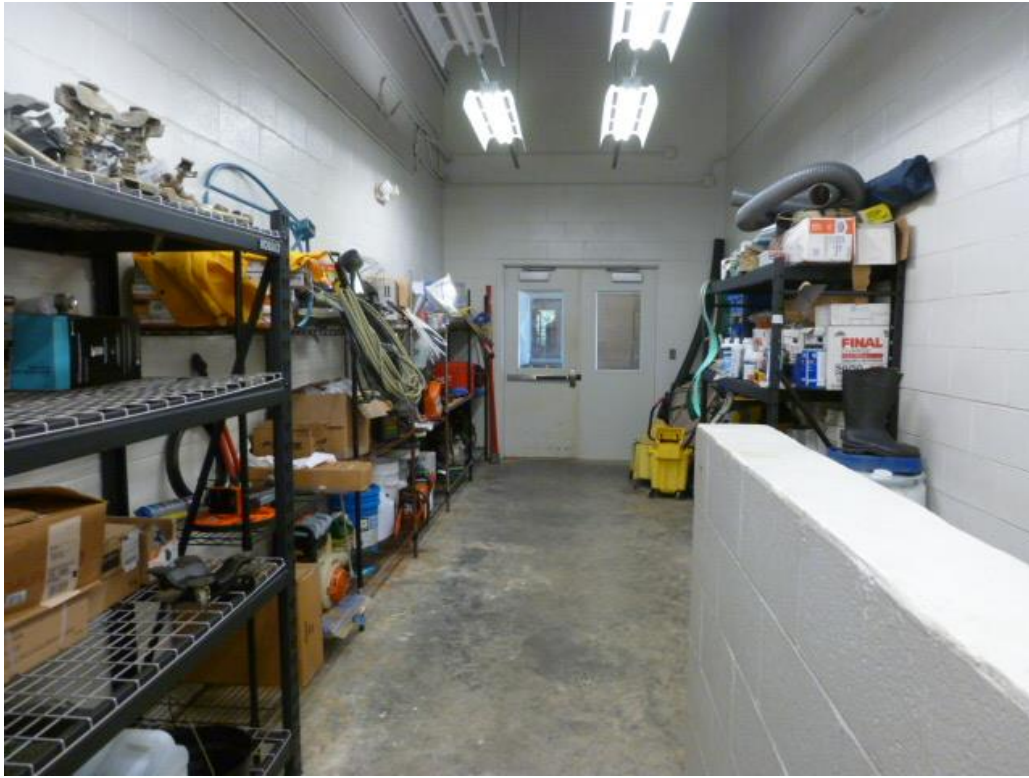
the pit area and recoated with sealant. No evidence of leaking was observed during this time. During this year’s inspection, it was noted that both pump station piping rooms need to be cleaned out due to bugs and debris. With respect to the new pump station storage room, this room was found to be sustainably filled with stored items during the last inspection. Since then, items have been relocated/stored to not impede access to the exit door (See *Appendix F – Photograph K*).

Photograph K –Storage Room Access

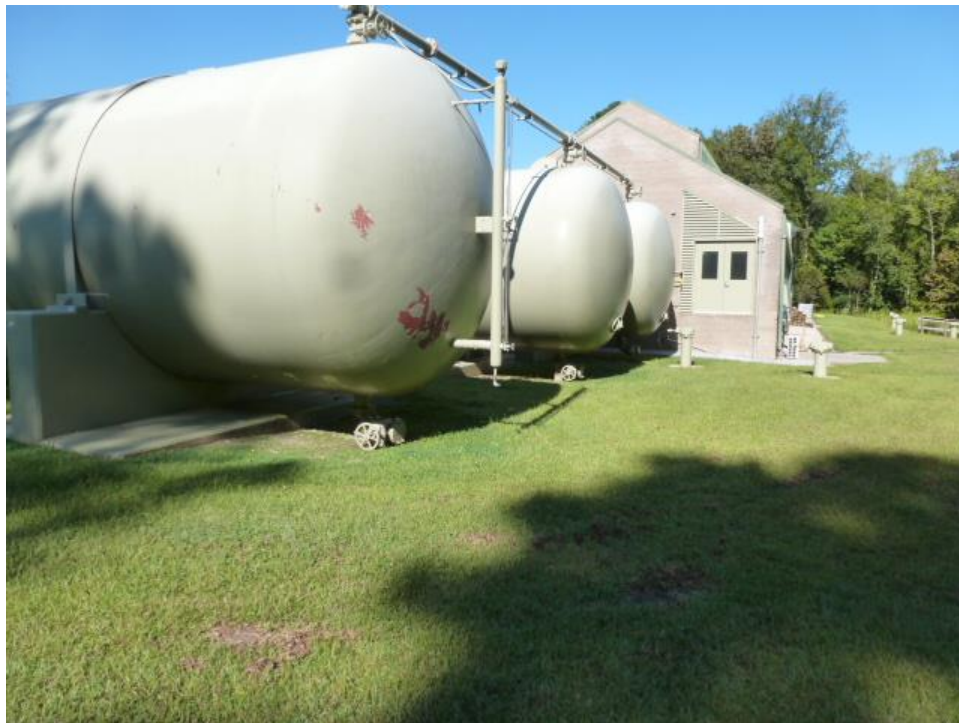
During this inspection, it was noted that the paint was failing in several areas especially on the tank drain valves and tank #3 (See *Appendix F – Photograph L and M*). Staff are in the process of addressing the situation.

Photograph L- Surge Tank 3 Paint Peeling

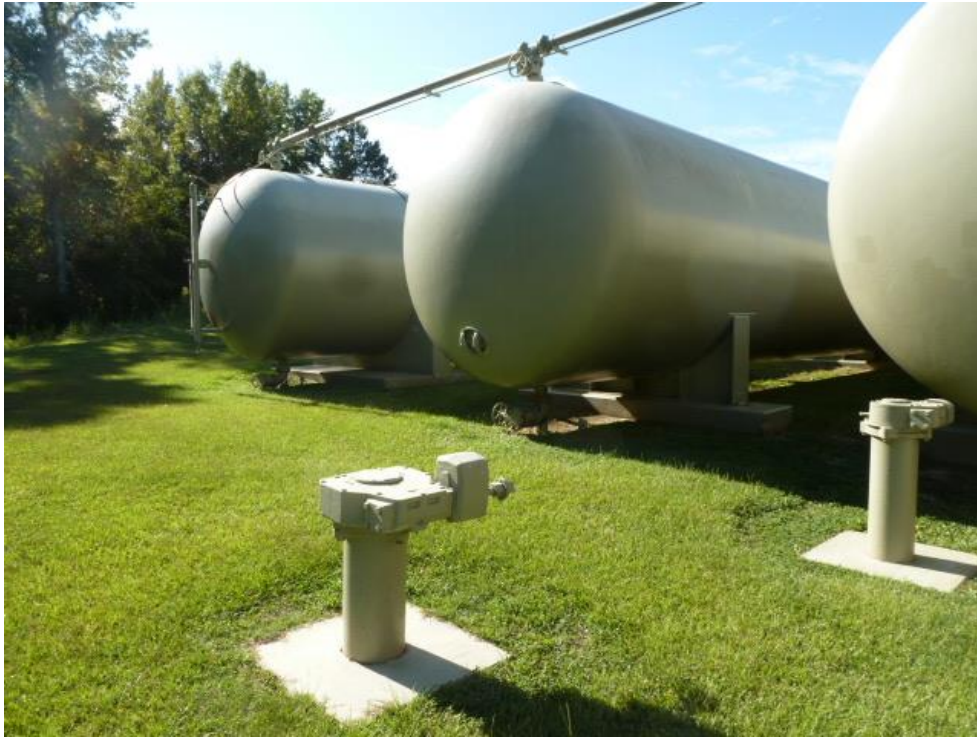
Photograph M- Surge Tank Valves Paint Peeling

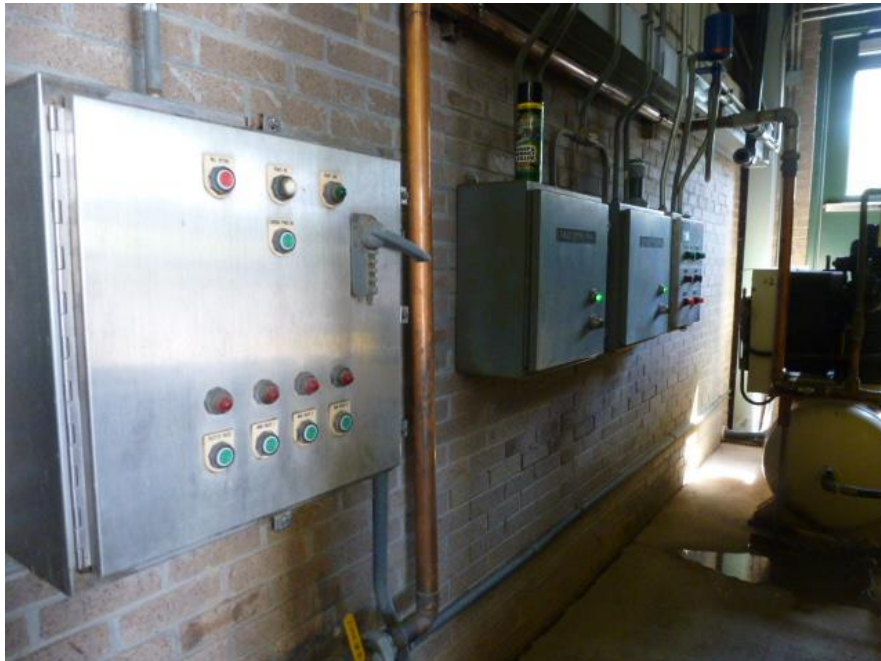
During the last inspection and with regards to the surge tank control panels located inside the pump station, several indicator lights still required replacement. Lights have since been replaced as of this inspection. Also, during this inspection, surge tanks 1 and 2 had their respective controls turned on, however tank 3 controls were off (See *Appendix F – Photograph*

Photograph N- Surge Tank Control Panels

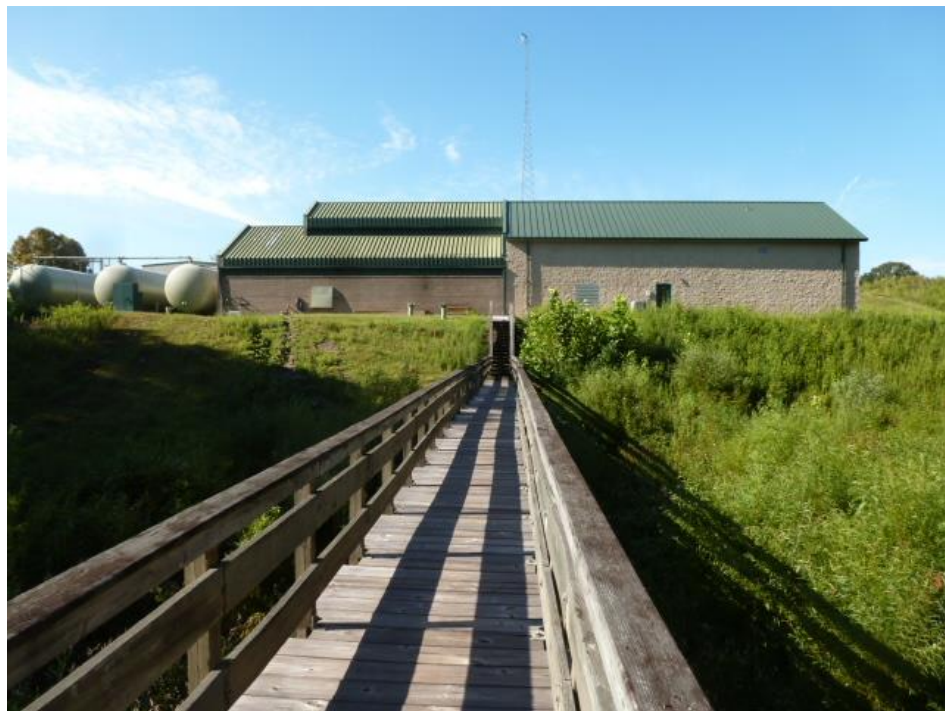
During the 2018 inspection, it was observed that the pier and walkways to the air-backwash control buildings needed repair. Several deck boards and handrails were in poor shape. During the 2019 inspection, it was noted that some repairs had been made (stair and plank replacement); however, more are still required. Also noted in previous reports, several areas on the older building's wall panels are still showing signs of rot. As of this inspection, the dock remains in bad condition (See *Appendix F - Photographs P*). The old backwash building remains in need of repair as wall boards are rotted. It is noted that the LCFWSA is currently under contract with McKim & Creed to design a replacement of the pier and air backwash buildings, however, it is recommended that the pier and buildings be maintained until such a time that project is completed.

Photograph P – Distressed Air Backwash Pier Access

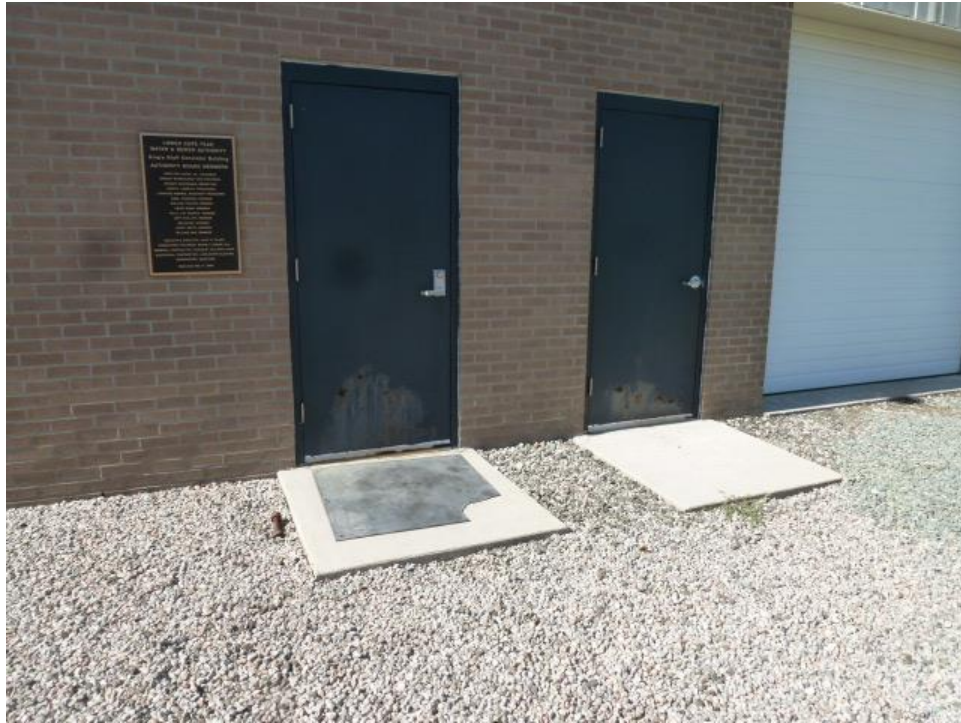
Also noted previously, the building personnel doors have rusted to such an extent that holes have appeared. Staff indicated new doors have been ordered and would be installed when they arrive. (See *Appendix F - Photograph Q*).

Photograph Q –Generator Building Corroded Doors

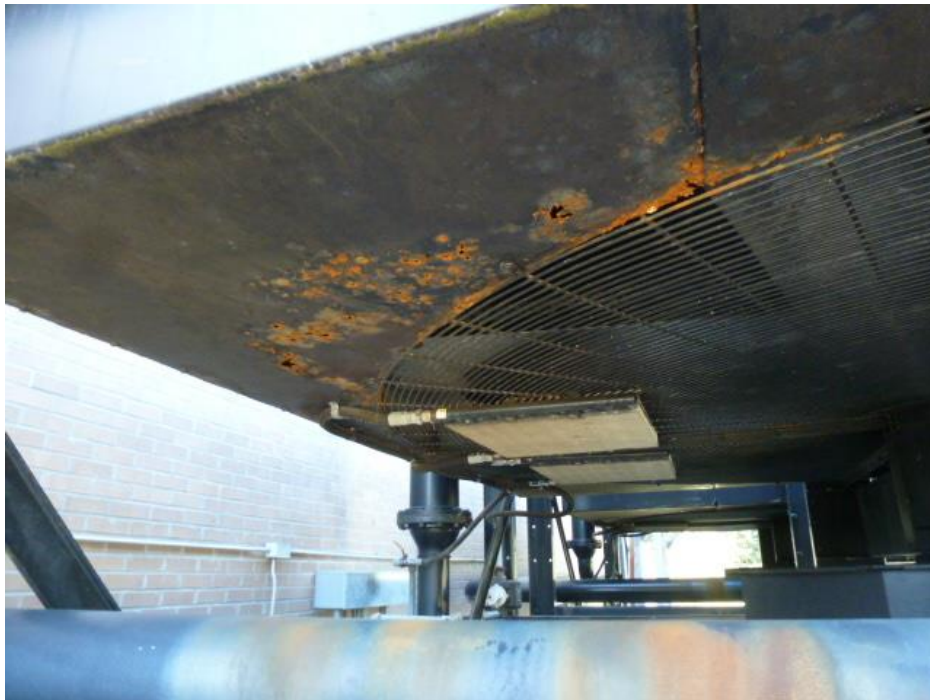
Generator radiators were reviewed during this inspection and were found to be in operable condition; however, rust was found to have advanced significantly on the underside fan shroud (See *Appendix F – Photograph R*). It is recommended staff monitor the area and plan to address the issue in the future.

Photograph R – Corroded Radiator Fan Shroud

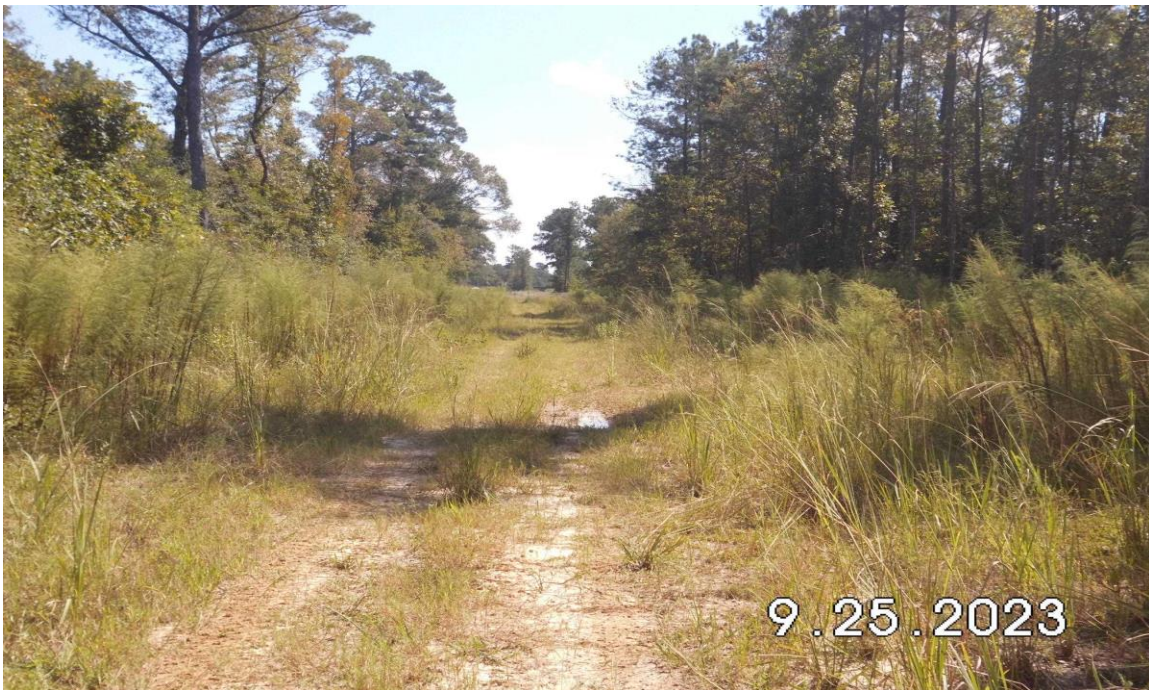
Photograph AA – Overgrown Area along Right-of-Way

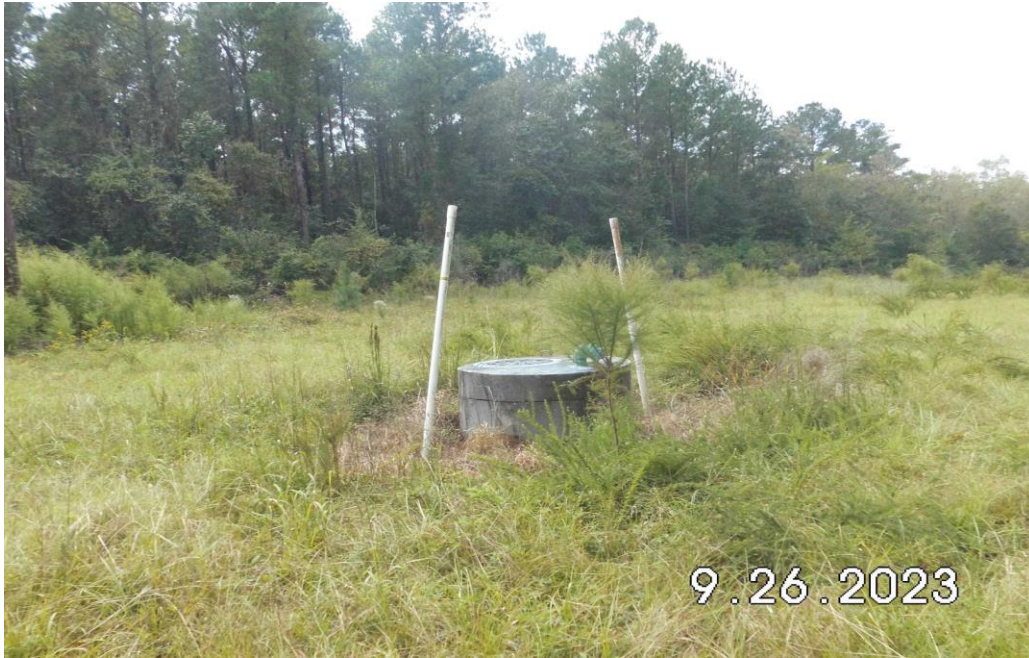
Photograph BB – Orange Painted Structure Marker Deterioration

1. Recommend painted 2" PVC poles painted "orange" to mark each valve structure.
2. Recommend all valve structures to be re-painted "blue".
3. Additional markers are needed to mark valve locations.

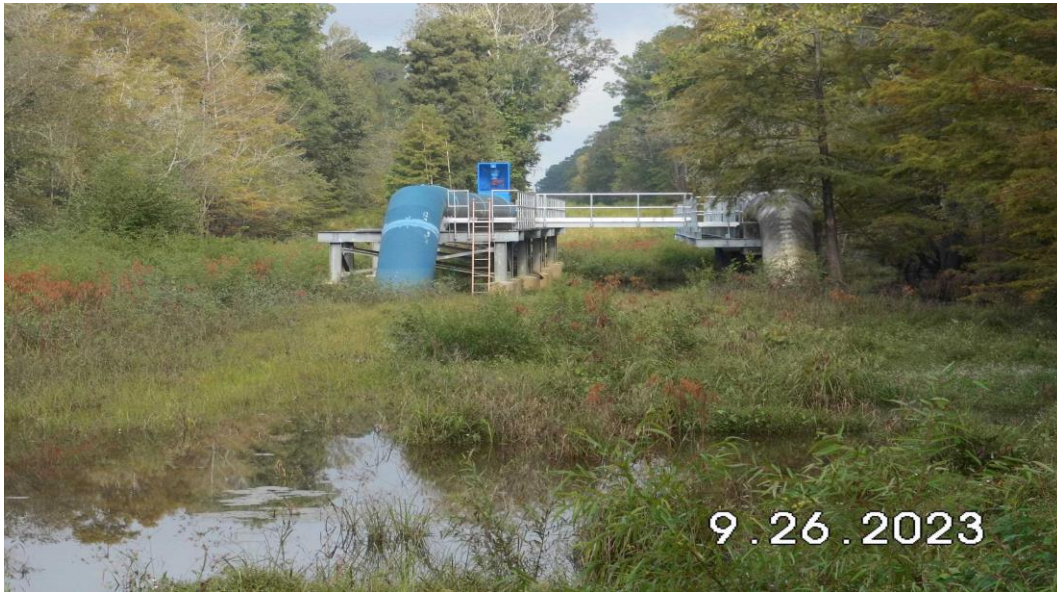
Also completed by Intracoastal Marine during the same time was a joint repair on the existing 48" PCCP elevated pipe where degradation of one of the existing joints had occurred. The contractor repaired the joint in accordance with specifications provided by the pipe manufacturer and at the direction of McKim & Creed's structural engineer. (See Photograph II)

Photograph II- Walkway Access across Livingston Creek on Existing 48" PCCP pipe

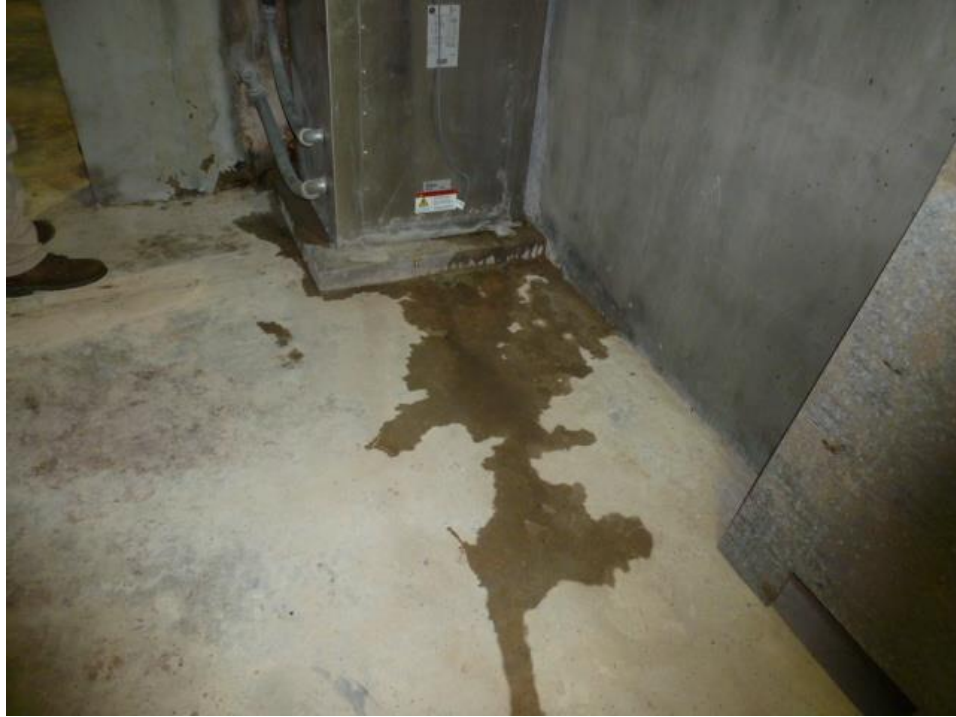
Photograph O – Filter Gallery Leak

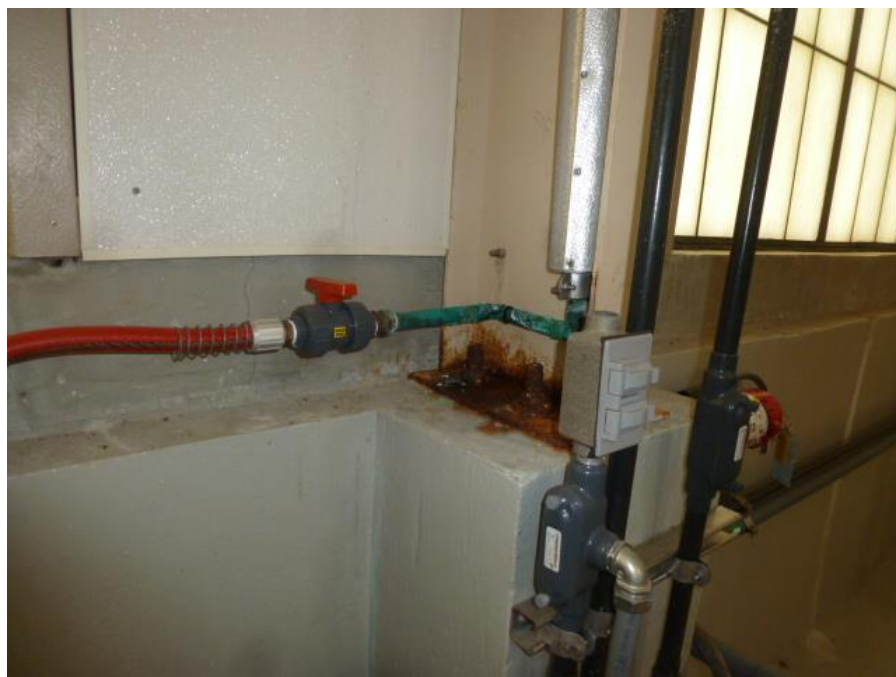
Photograph T –Chemical Building Corroding Column
