**Lower Cape Fear Water & Sewer Authority
1107 New Pointe Boulevard, Suite # 17, Leland, North Carolina
9:00 a.m. – Regular Monthly Board Meeting
November 14th, 2022**

**Lower Cape Fear Water & Sewer Authority
Kings Bluff Regional Raw Water Supply Facilities
FY 2022-2023 Annual Inspection Report**

Kings Bluff Pumping Station Annual Inspection

FY 2022-2023 Annual Inspection Report

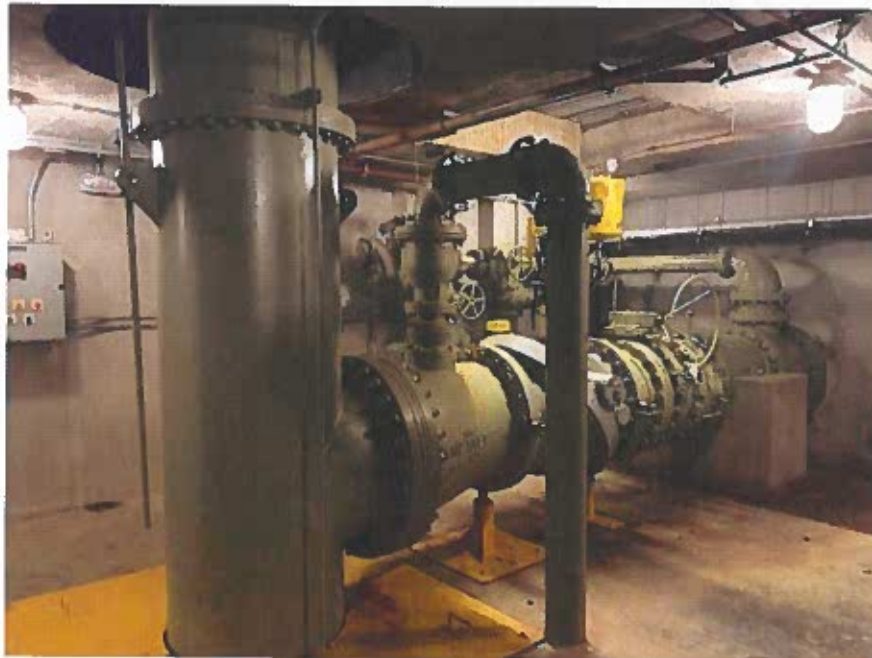
Photograph B – Spare Check Valve on Pump

During this year's inspection, the 1,600 HP vertical turbine pumps (installed as part of the 2009 expansion/upgrade of the Kings Bluff facility) were inspected and found to be in excellent condition and meeting the needs of the Authority's customers (See *Appendix F -Photograph A*). Staff indicated that pump 5 was scheduled to be serviced this year. To be serviced, the pump and it's suction will be removed and sent to Charles Underwood Pump Company. Currently the contractor is awaiting the replacement parts before removing the pump. Staff also indicated the check valve on pump 5 had been swapped out with a spare while the original was also being rebuilt (See *Appendix F - Photographs B*).

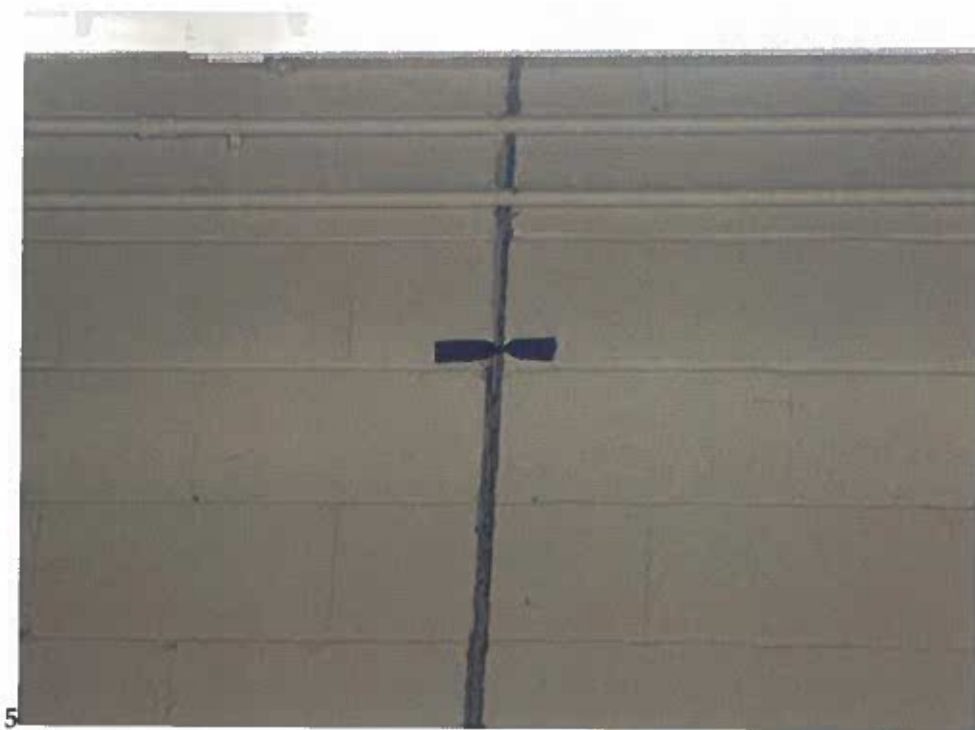
Photograph C – Existing Crack in Electrical Building Wall

The 1,600 HP pumps are controlled by a separate electrical control room housing variable frequency drives and motor starters. During the 2016 inspection, it appeared that the masonry wall to wall joints located inside the new pump station electrical building had shifted producing cracked paint at the intersection of the walls. The most noticeable crack is located on the masonry wall joint located west of the western most roll up door. Since the 2016 inspection, Engineer reviewed the joints and found that the issue was not structurally detrimental; however, it was recommended that staff should continue to monitor the issue. During this inspection, visual observation indicated that the size of the separation did not appear to have increased (See *Appendix F - Photographs C*). It is recommended that the wall separation continue to be monitored.

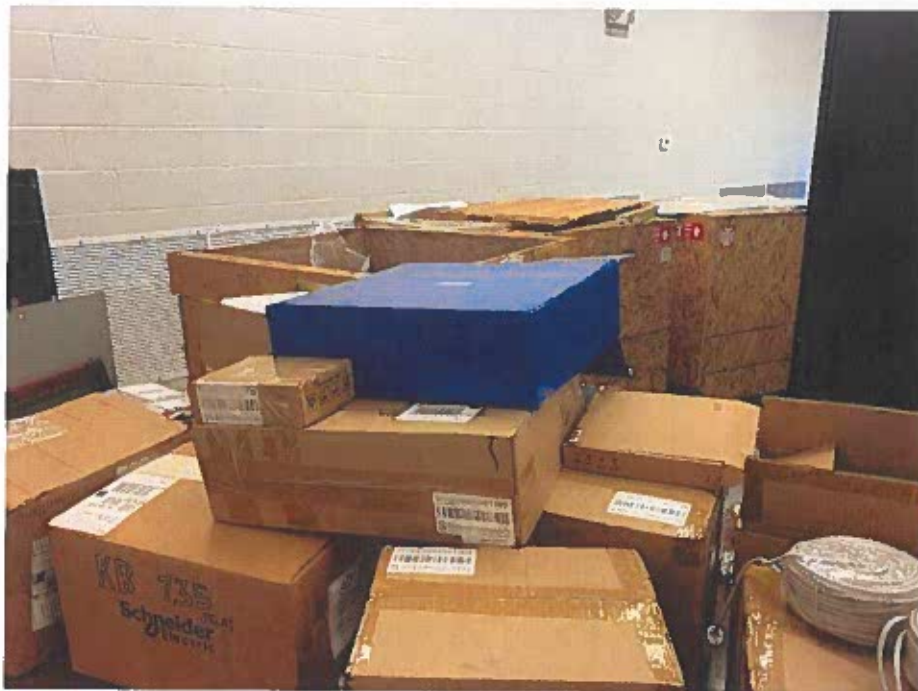
Photograph D – Debris/Stored Items in Electrical Room

During review of the electrical room interior, it was noted that a pump VFD had been replaced. Additionally, it was noted many items were being stored inside the room creating a possible fire hazard and possibly impeding access to exit doors. It is therefore recommended the room be cleared of excessive storage and those items that remain be moved so as to not obstruct exit from the building (See *Appendix F - Photographs D*).

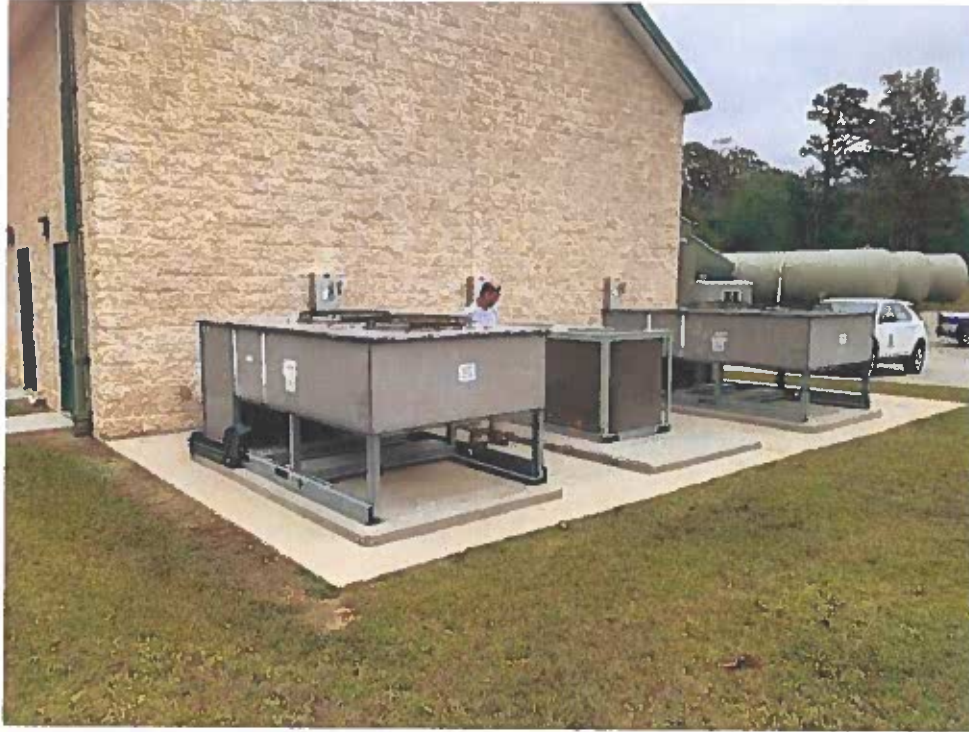
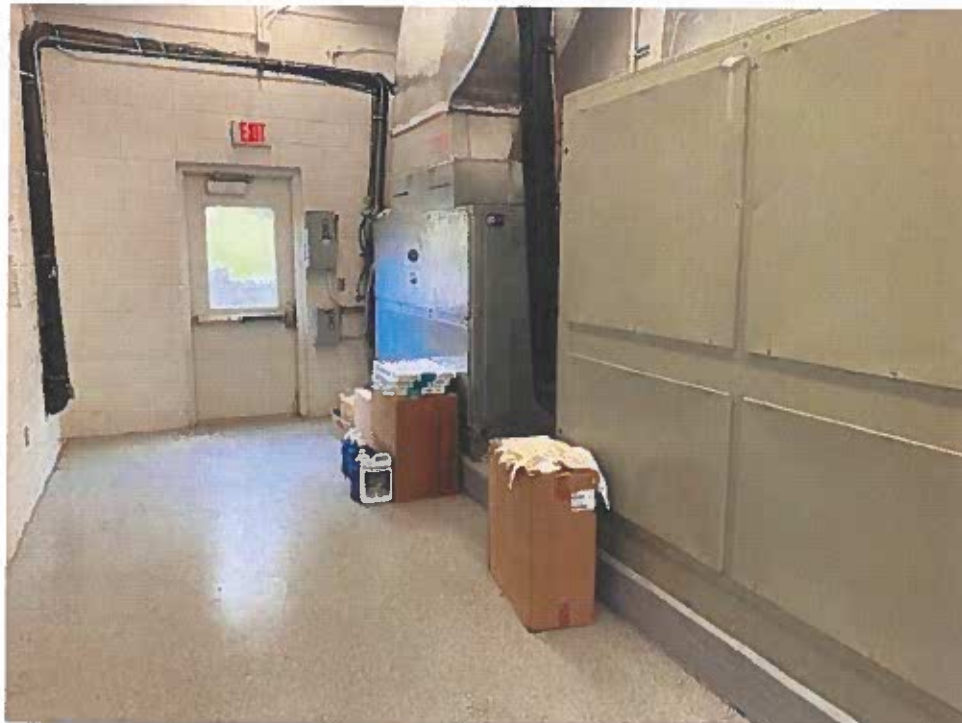
Adjacent to the new electrical control room is a HVAC room housing the HVAC equipment (See *Appendix F - Photographs E and F*). It was observed that since the last inspection, a new HVAC unit had been installed outside with an associated air handler inside. It is recommended that the HVAC openings which allow duct work to pass between the HVAC room to the electrical room be sealed so as to prevent short circuiting of the unit and the unnecessary cooling of the HVAC room. All exterior HVAC units were reviewed and were clear of any debris blocking the radiator coils. It was however noted that HVAC piping insulation outside had failed in a few areas and thus it is recommended it be addressed.

Photograph E – New HVAC unit for Electrical Room

Photograph F – New HVAC Air Handling unit

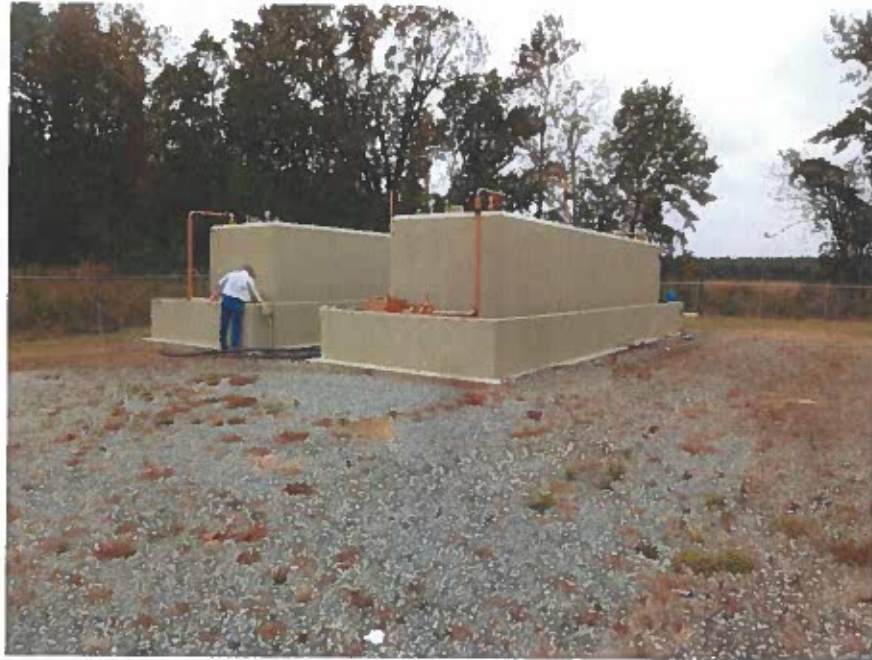
Photograph G – Diesel Fuel Storage Tanks

The two 3.0 Mega Watt standby generators are supplied fuel by (2) 12,000-gallon concrete fuel tanks, which are located adjacent to the generator building. The tanks were installed with a 110% secondary containment wall to capture overflow, ruptures or spills of diesel fuel. The external fuel tanks were inspected and found to be in acceptable condition. Rain water collects in the containment area and is drained by LCFWSA operator after each significant rain event. On both tanks during past inspections, significant efflorescence was noted. During this year's inspection, both tanks were observed to be in excellent condition; however they were missing the proper signage (See *Appendix F – Photograph G*).

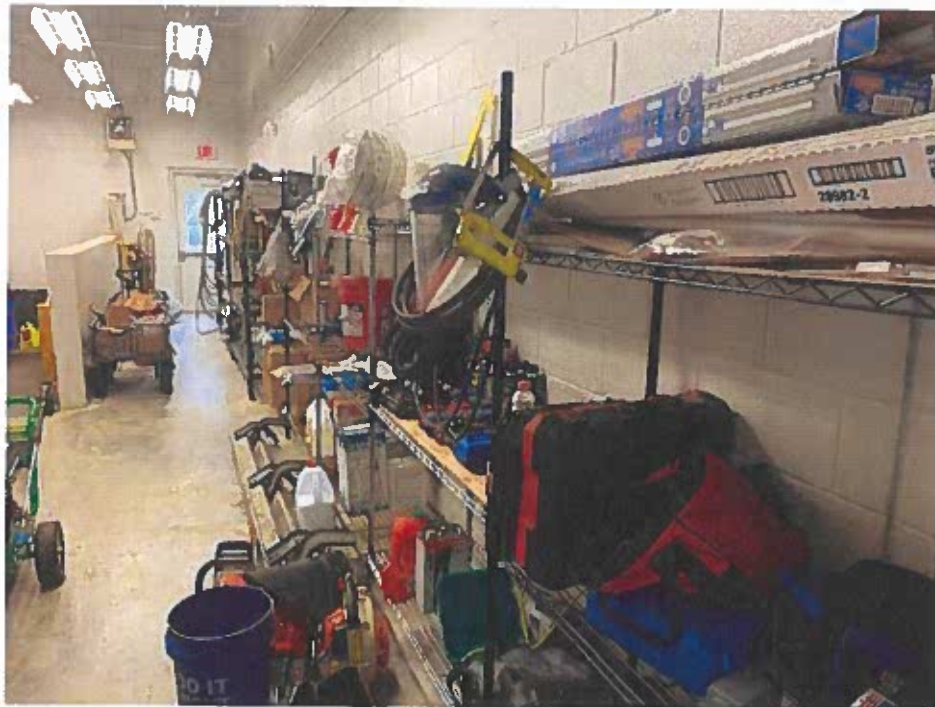
Photograph H –New Pump Station Storage Room

- During the time of the 2011-2012 inspection, O&M staff noted that the containment area provided in the new pump station building for storage of oil floods and then subsides with heavy rains. Staff has addressed this issue by installing a French drain outside of the facility. The drain was placed against the wall and appears to be reducing the hydrostatic water load against the wall. In addition, staff applied another layer of sealant to the interior face of the CMU wall. No water/moisture was present during the inspection and staff reported the drain and sealant appear to be working. During the 2019 inspection, staff indicated they had placed approximately 12 inches on concrete in the pit area and recoated with sealant. No evidence of leaking was observed during at this time. During this year's inspection, it was noted that both pump station piping rooms need to be cleaned out due to bugs and debris. With respect to the new pump station storage room, this room was found to be sustainably filled with stored items. So much so that they encumber access to the room exits. It is therefore recommended that the room be cleaned and reorganized to an extent that the exits can be accessed should power be out (See *Appendix F – Photograph H*).

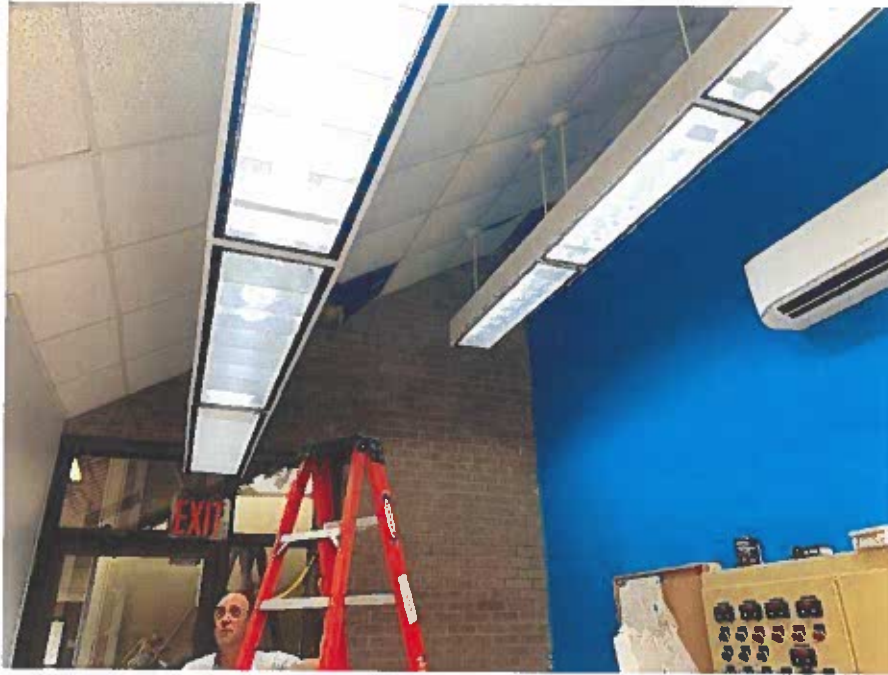
Photograph I – Refurbishment of Old Electrical Room

- Also during this year's inspection, it was found that the Owner is refurbishing the Old Pump Station electrical room. The room has been cleared of debris and new lighting, ceiling tiles, and air conditioning was being installed (See *Appendix F – Photograph I*).

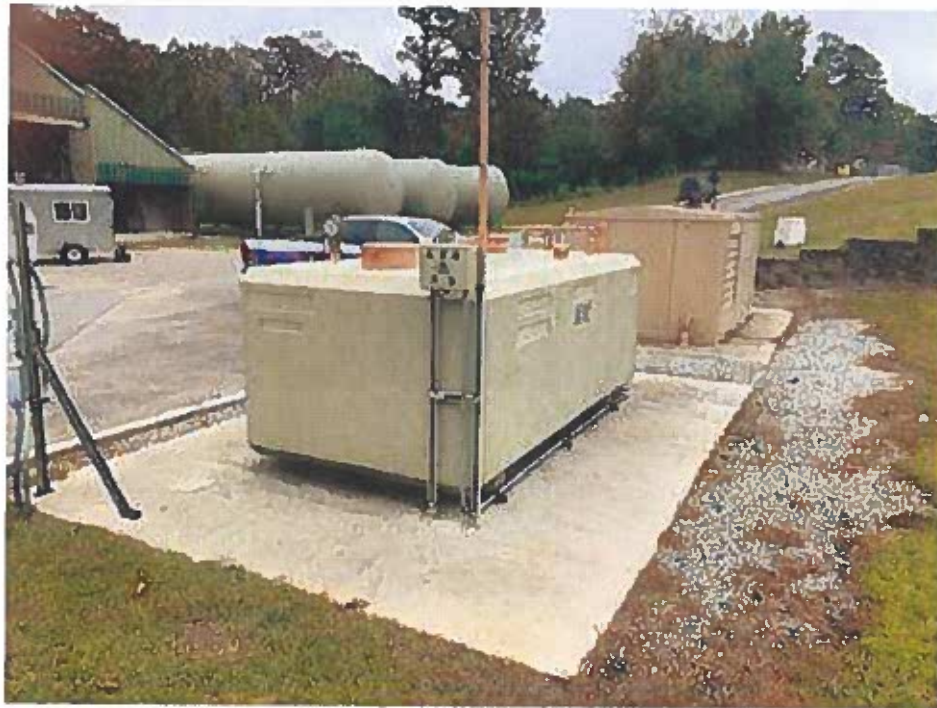
Photograph J - Small Generator and Tank

During the 2018 inspection, it was noted that several valve operator wheels were broken. The handwheels were replaced with operator nuts, correcting the problem, as documented in the 2019 inspection. Previously the small generator located in front of the pump station was showing signs of rust likely due to moist conditions that existed prior to plant staff addressing flooding issues. During this visit it was noted that the generator and fuel tank had been painted and there are no signs of rust or corrosion; although, the generator and tank were missing the proper signage. (See *Appendix F - Photographs J*).

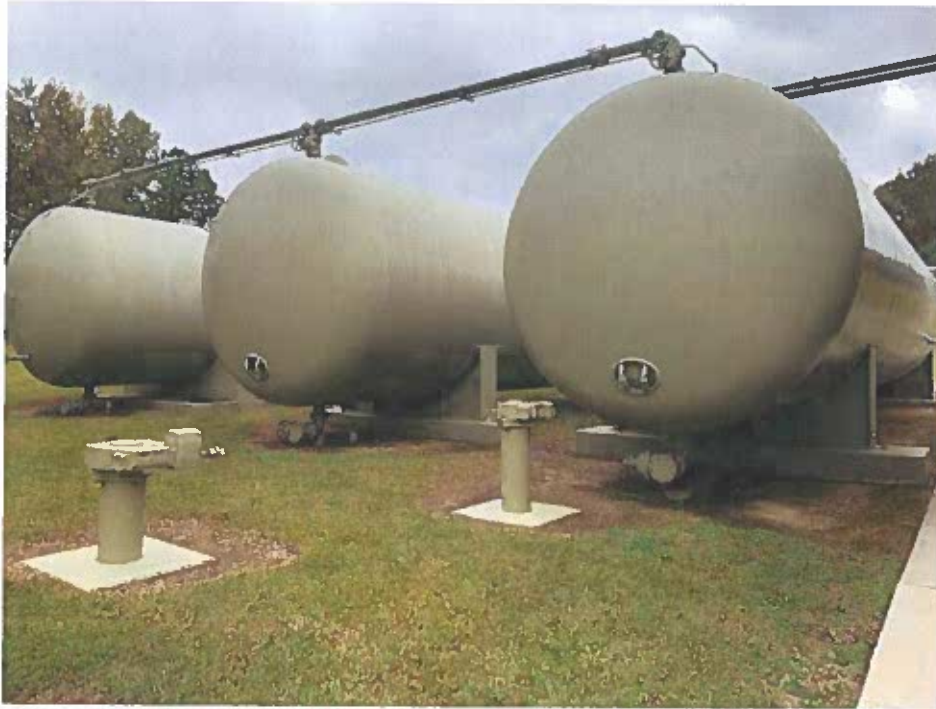
Photograph K –Surge Tankage

During the 2021 inspection, six (6) drain valves were observed to have been replaced. During this inspection, tankage appears to be in good condition (See *Appendix F – Photograph K*) however it is recommended that the drain valves be insulated and heat traced so that they don't freeze and break again.

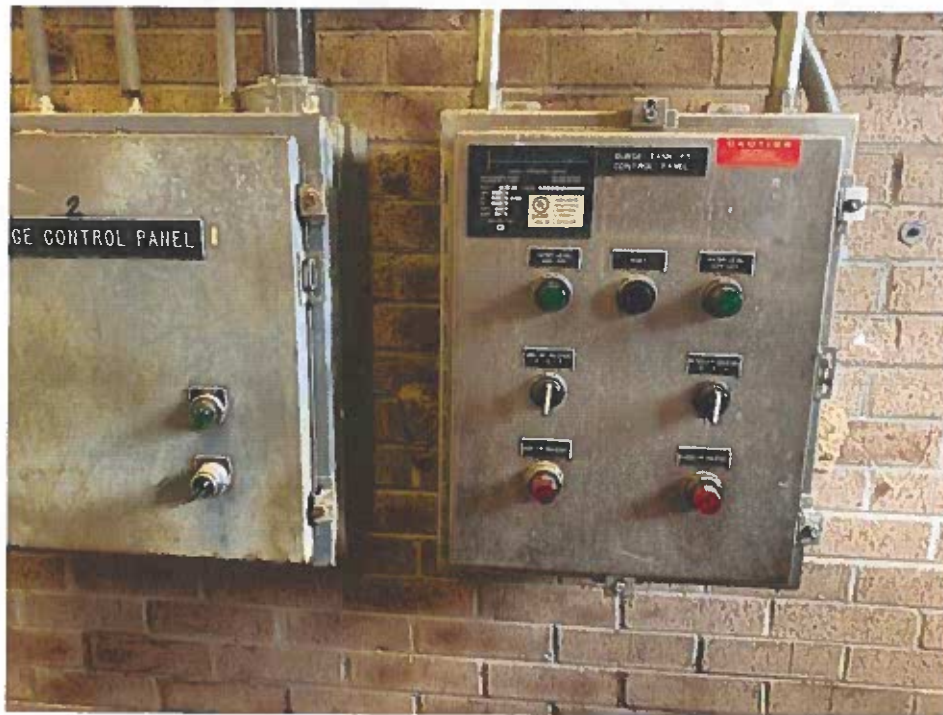
During the last inspection and with regards to the surge tank control panels located inside the pump station, several indicator lights still required replacement. Also during the previous inspection, surge tank 1 and 2 had their respective controls turned off however during this inspection tank 3 had its controls off and lights had not yet been replaced (See *Appendix F -*

Photographs L). The water level in tank 3 also appeared rather low when compared to the other tanks. It is recommended that the surge system operation be examined, and proper operation confirmed. Please note that for proper operation and protection of the new force main, all 3 surge tanks are required to operate.

Photograph L- Surge Tank 3 Control Panel Power Off

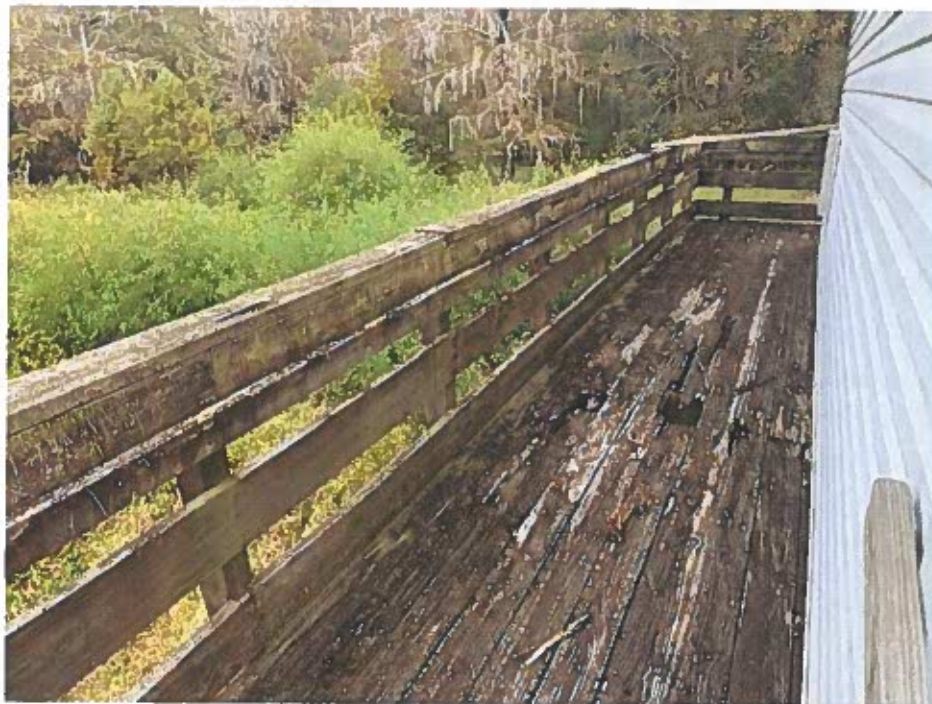
During the 2018 inspection, it was observed that the pier and walkways to the air-backwash control buildings needed repair. Several deck boards and handrails were in poor shape. During the 2019 inspection, it was noted that some repairs had been made (stair and plank replacement); however, more are still required. Also noted on previous reports, several areas on the older building's wall panels are still showing signs of rot. As of this inspection, dock was in worse condition with some areas being blocked off since last year because the deck was completely compromised (See *Appendix F - Photographs N and O*). The old backwash building remains in need of repair as wall boards are rotted. The backwash control panel indicator lights need to be replaced in both buildings. Staff indicated during this visit that one of the butterfly valves on the new backwash system appeared to "sticking" and thus they had plans to remove and service the unit. It is noted that the LCFWSA has identified replacement of the pier and air backwash buildings as a future Capital Project, however, it is recommended that the pier and buildings be maintained until such time that project is completed.

Photograph N- Failed Deck Adjacent to New Backwash House

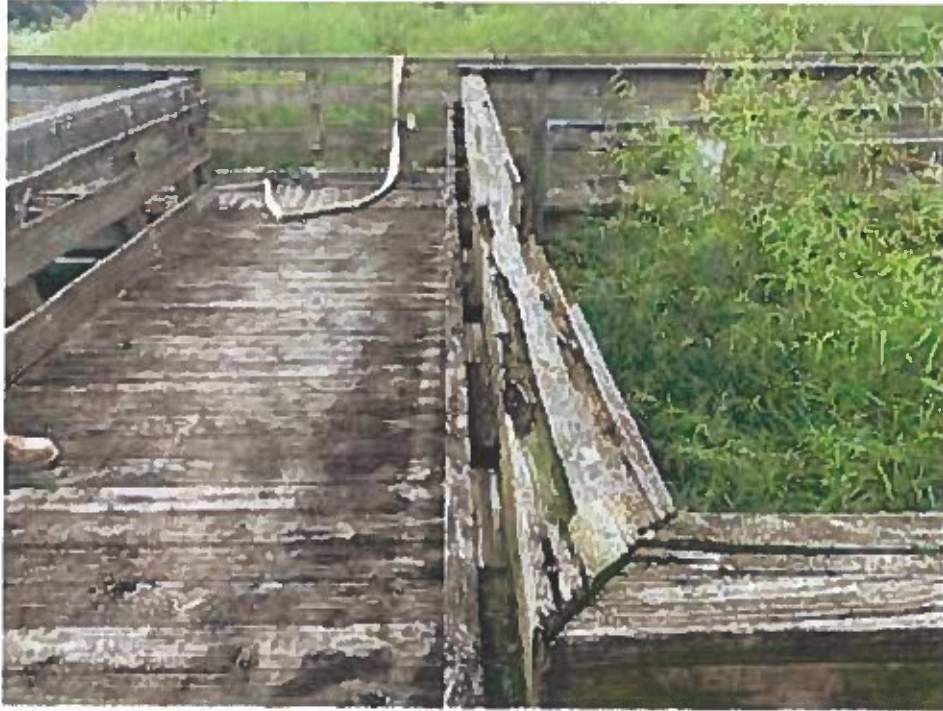
Photograph O – Failed Handrails near New Backwash House

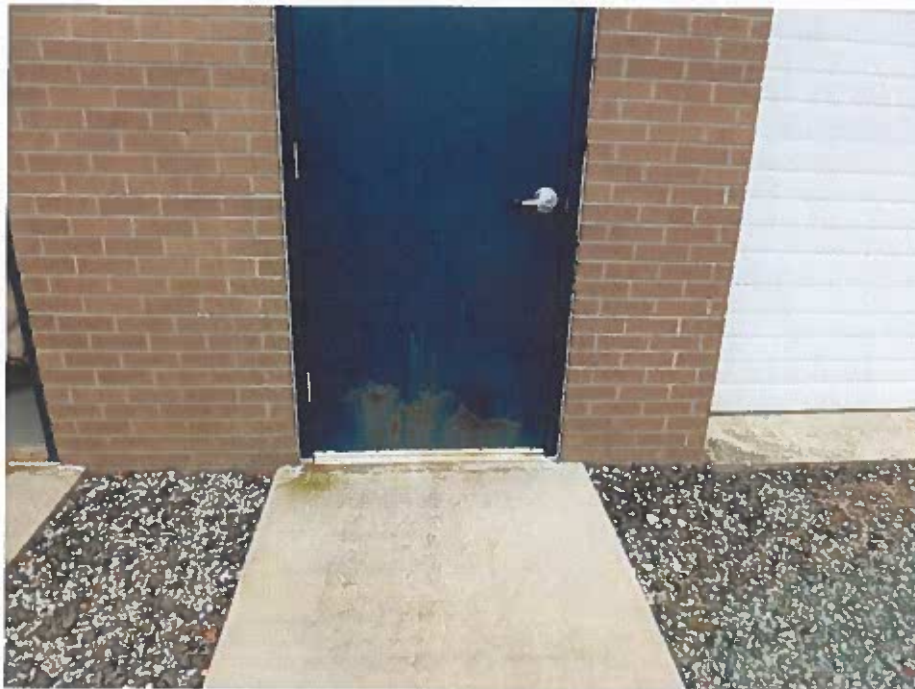
Also noted previously, the building personnel doors have rusted to an extent that holes have appeared. It is not recommended that they be replaced at this time however should be monitored and replaced in the future when they are further compromised. (See *Appendix F – Photograph P*).

Photograph P – Corroded Personnel Doors at Generator Bldg

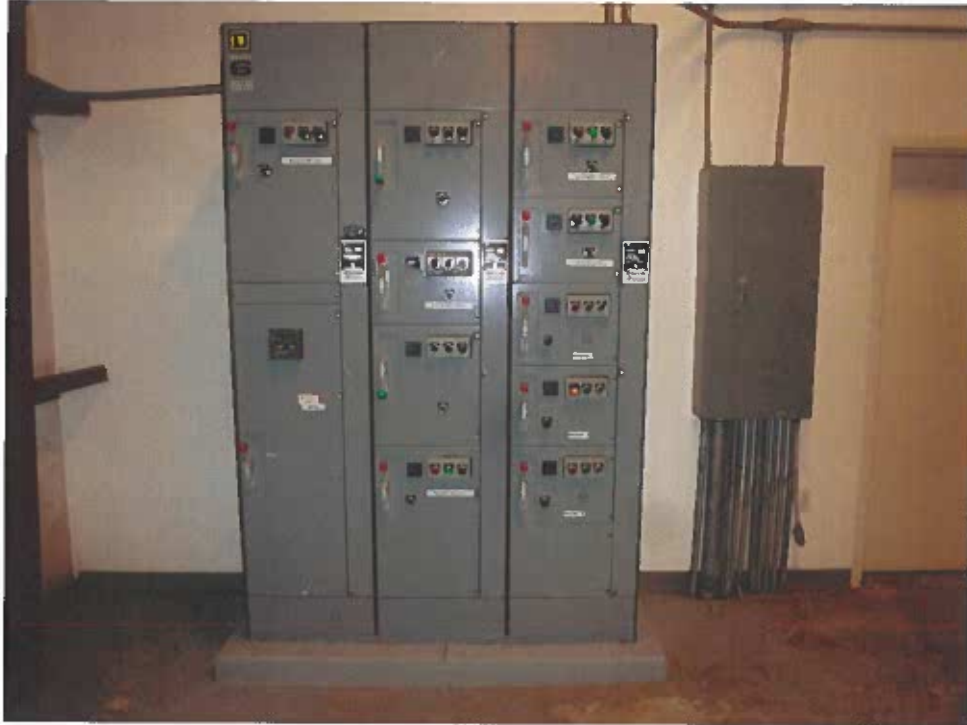
Photograph Q – Breaker Panel in Generator Building

Also noted previously, it was observed that the breaker panel located in the generator room had an excessive amount of failed indicator lights and thus should be serviced. This issue still needs to be addressed (See *Appendix F – Photograph Q*).

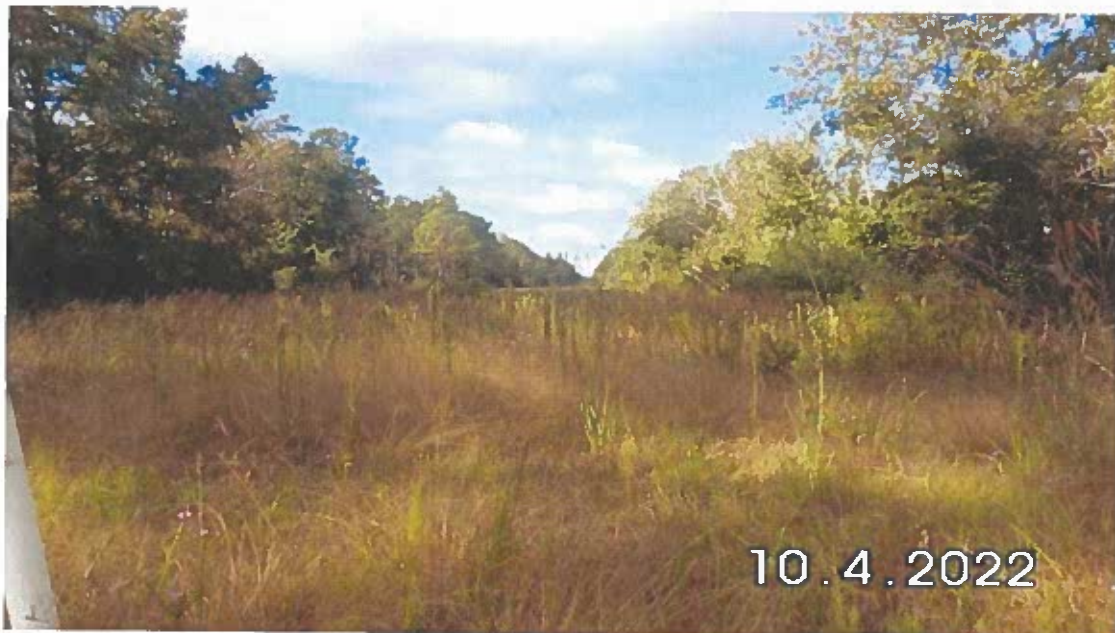
Photograph AA – Overgrown Area along Right-of-Way

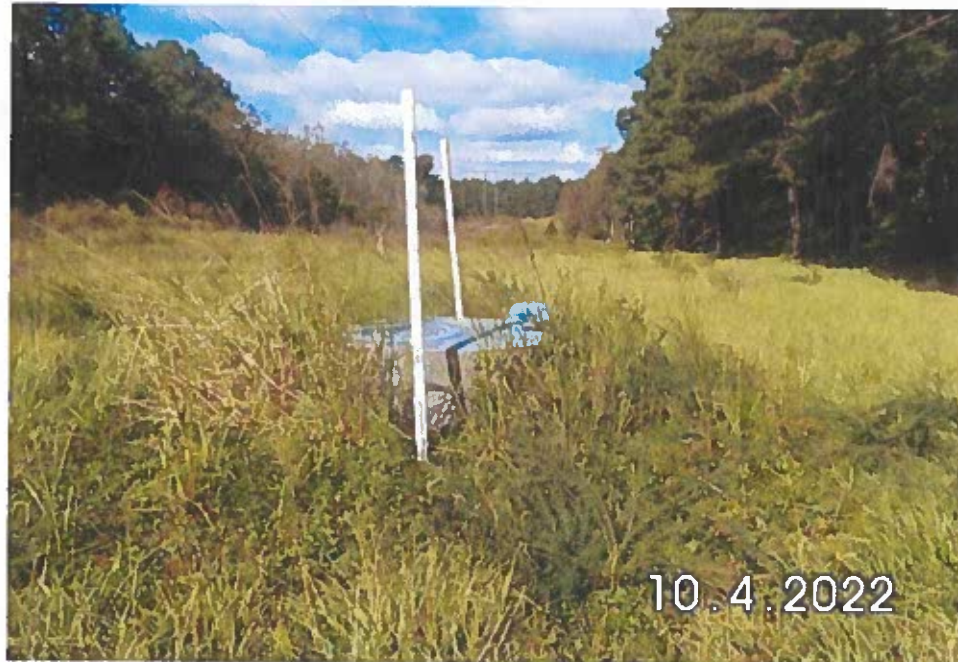
Photograph BB – Orange Painted Structure Marker Deterioration

1. Recommend painted 2" PVC poles painted "orange" to mark each valve structure.
2. Recommend all valve structures to be re-painted "blue".
3. Additional markers needed to mark valve locations.

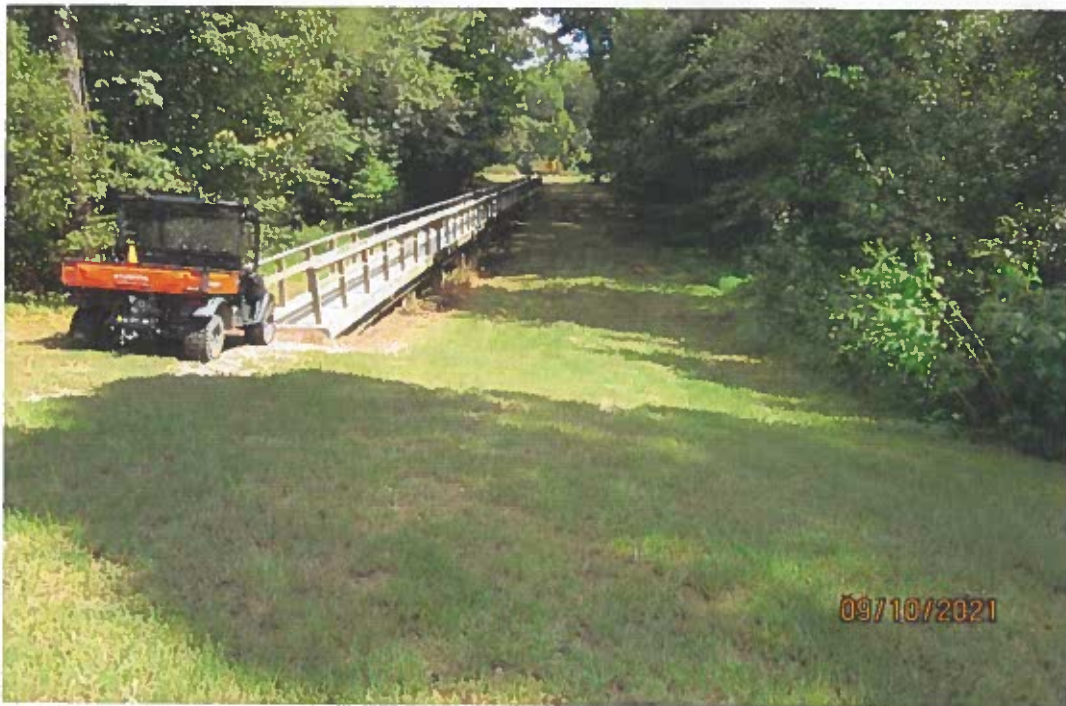
Photograph D – Deck and rails are replaced. Grounds are weeded and mowed

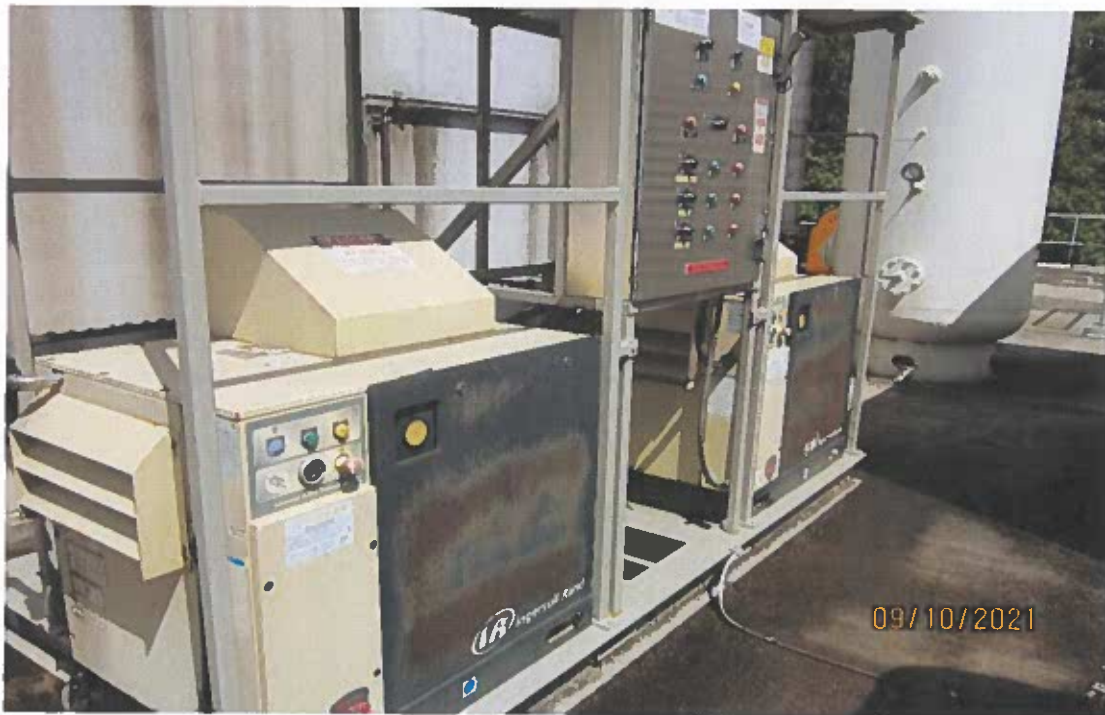
Photograph H – Restored air compressor skid support framing
